**Flood Control Project Maintenance
Levee Inspections**

Fall 2013 Levee Maintenance Deficiency Summary Report

Reclamation District No. 1500 Sutter Basin

Waterway	Bank	Unit Miles
Unit No. 01 Sacramento River	Left	33.58

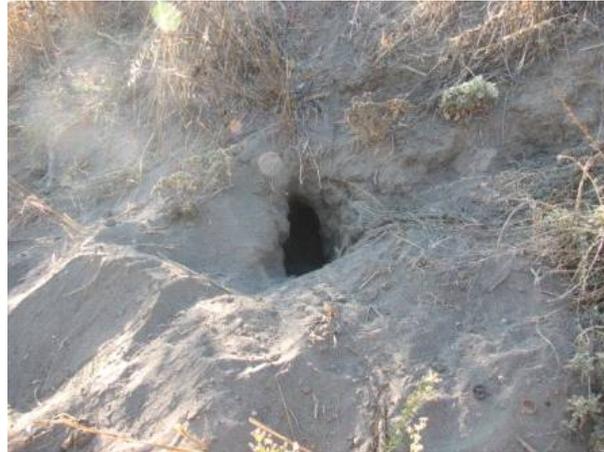
Levee Mile Report Line	5
Start Levee Mile	0.03
End Levee Mile	0.03
Location	Land Side
Category	Earthen Levee
Item	Animal Control
This is one of several rodent holes in the area.	
johngw_f_20130924_386.jpg

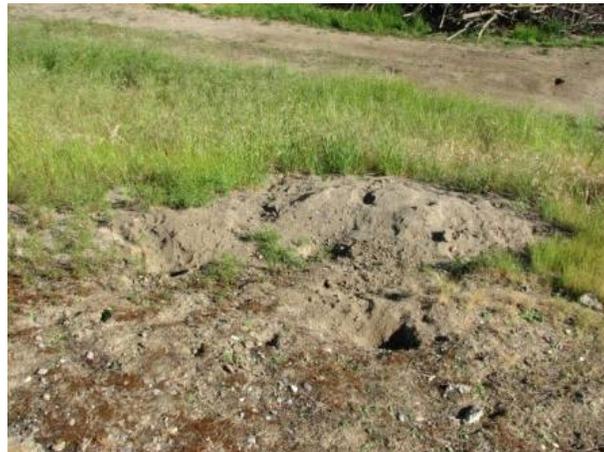
Levee Mile Report Line	5
Start Levee Mile	0.03
End Levee Mile	0.03
Location	Land Side
Category	Earthen Levee
Item	Animal Control
There are many rodent holes a short distance away from the last photo.	
johngw_f_20130924_388.jpg

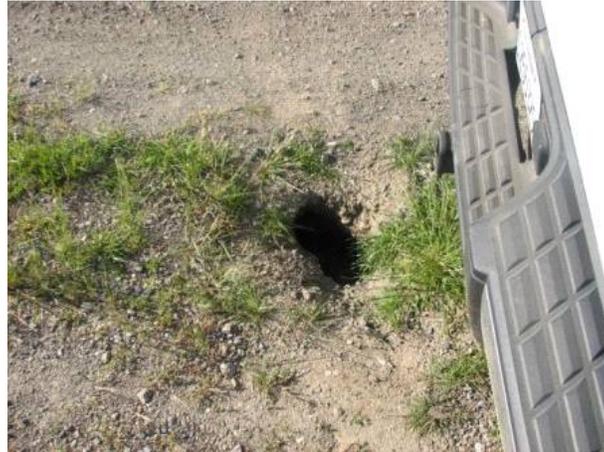
Levee Mile Report Line	6
Start Levee Mile	0.04
End Levee Mile	0.04
Location	Crown
Category	Earthen Levee
Item	Animal Control
A rodent hole in the levee crown, photo taken spring 2012.	
johngw_f_20130924_410.jpg

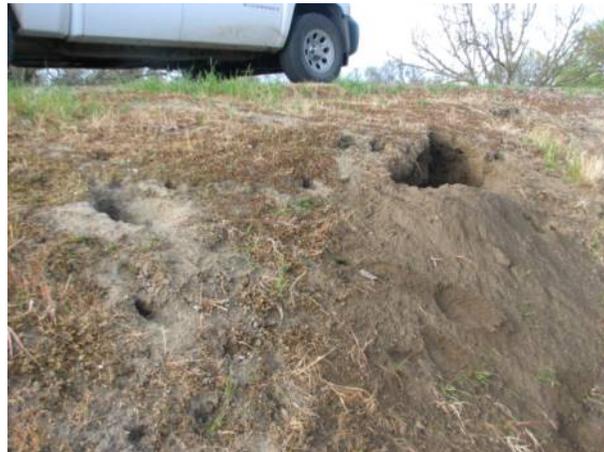
Levee Mile Report Line	7
Start Levee Mile	0.05
End Levee Mile	0.05
Location	Land Side
Category	Earthen Levee
Item	Animal Control
Many rodent holes and a large one that a dog has enlarged Spring 2013	
johngw_f_20130924_451.JPG

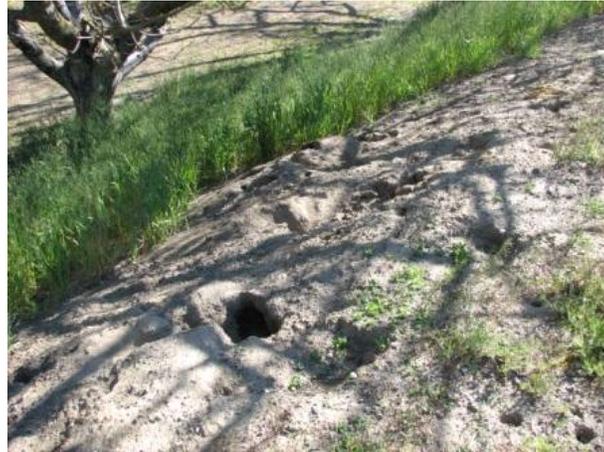
Levee Mile Report Line	8
Start Levee Mile	0.07
End Levee Mile	0.07
Location	Land Side
Category	Earthen Levee
Item	Animal Control
<p>There are some old and a few new rodent holes that need to be backfilled.</p>	
<p>johngw_f_20130924_372.jpg</p>

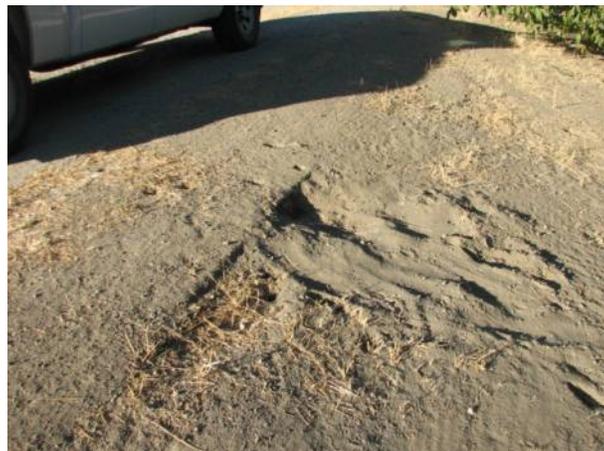
Levee Mile Report Line	9
Start Levee Mile	0.10
End Levee Mile	0.10
Location	Water Side
Category	Earthen Levee
Item	Animal Control
<p>Rodent holes along the levee shoulder. Photo fall 2012.</p>	
<p>johngw_f_20130924_489.jpg</p>

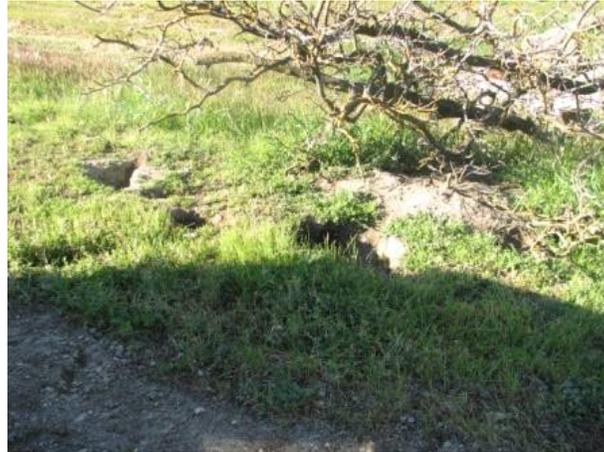
Levee Mile Report Line	10
Start Levee Mile	0.28
End Levee Mile	0.28
Location	Water Side
Category	Earthen Levee
Item	Animal Control
Several rodent holes on the waterside levee slope, photo taken spring 2012.	
johngw_f_20130924_458.jpg

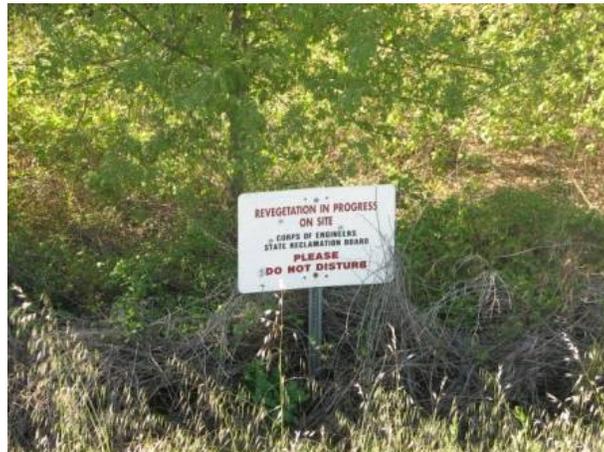
Levee Mile Report Line	15
Start Levee Mile	0.57
End Levee Mile	0.83
Location	Water Side
Category	Earthen Levee
Item	Vegetation
A revegetation site waterside toe, photo taken spring 2012.	
johngw_f_20130924_462.jpg

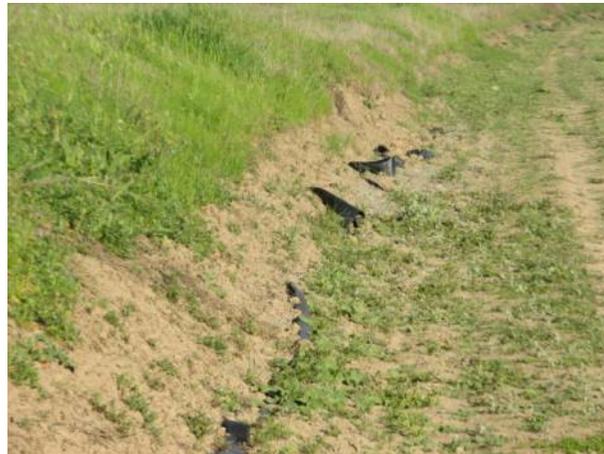
johngw_f_20130924_467.JPG

Damage to the seepage berm during the flood season needs to be repaired, Spring 2013

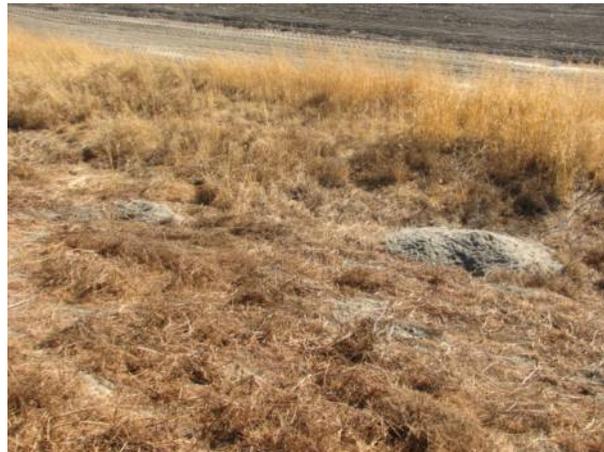
johngw_f_20130924_452.jpg

Levee Mile Report Line	17
Start Levee Mile	1.20
End Levee Mile	1.20
Location	Land Side
Category	Earthen Levee
Item	Animal Control

A couple of large rodent holes on the levee slope. Photo fall 2012.

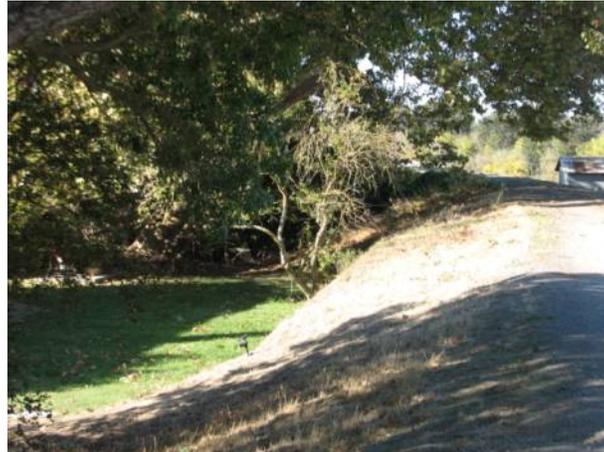
Levee Mile Report Line	18
Start Levee Mile	1.34
End Levee Mile	1.34
Location	Land Side
Category	Earthen Levee
Item	Vegetation
Landscape with retaining wall that is in the USACE as-builts Fall 2013	
johngw_f_20131007_938.JPG

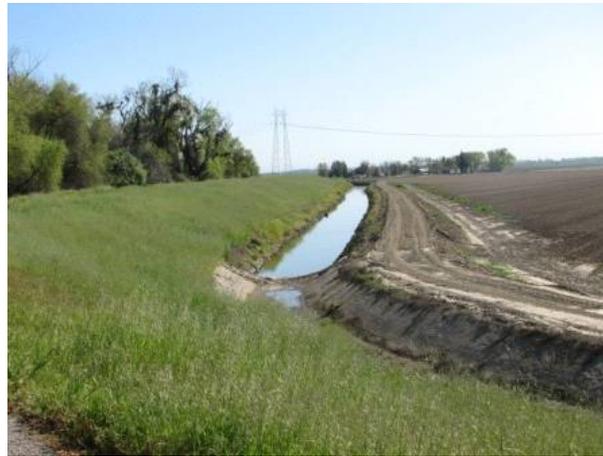
johngw_f_20130924_494.jpg

Levee Mile Report Line	21
Start Levee Mile	2.57
End Levee Mile	3.83
Location	Land Side
Category	Earthen Levee
Item	Encroachments

Agricultural ditch, photo was taken in spring 2010.

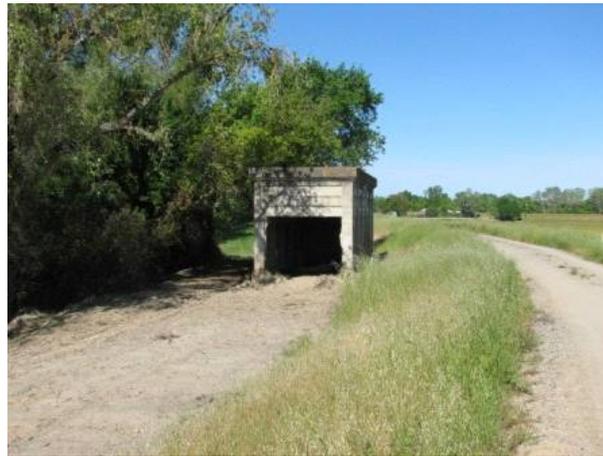
johngw_f_20130924_373.jpg

Levee Mile Report Line	22
Start Levee Mile	3.73
End Levee Mile	3.73
Location	Water Side
Category	Earthen Levee
Item	Encroachments

The photo is of the abandoned pumphouse. The district has placed a steel plate over the old outlets. They have began filling the structure for safety.

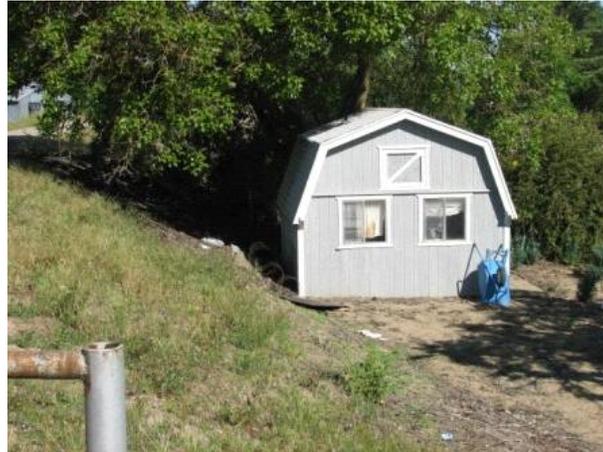
Levee Mile Report Line	23
Start Levee Mile	3.98
End Levee Mile	3.98
Location	Land Side
Category	Earthen Levee
Item	Encroachments
<p>A small building is encroaching into the landside levee toe.</p>	
<p>johngw_f_20130924_374.jpg</p>

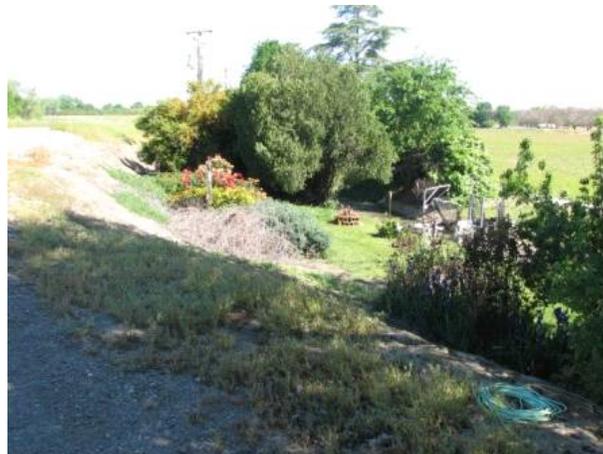
Levee Mile Report Line	24
Start Levee Mile	4.01
End Levee Mile	4.01
Location	Land Side
Category	Earthen Levee
Item	Vegetation
<p>The landscape is planted into the encroachment zone within 15' of the toe.</p>	
<p>johngw_f_20130924_375.jpg</p>

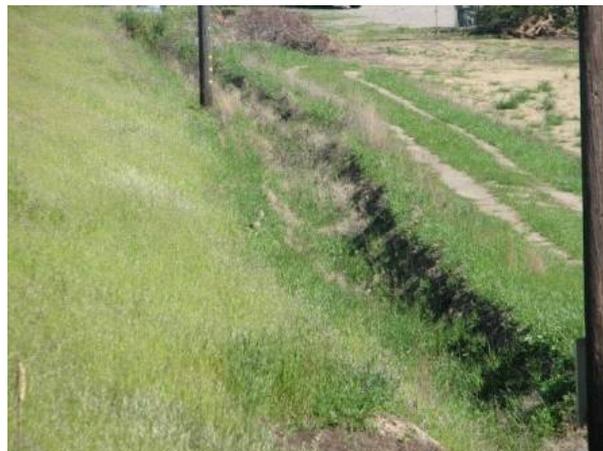
Levee Mile Report Line	25
Start Levee Mile	4.04
End Levee Mile	4.16
Location	Land Side
Category	Earthen Levee
Item	Encroachments
<p>An agricultural ditch runs along the toe of the levee, photo taken spring 2012.</p>	
<p>johngw_f_20130924_446.jpg</p>

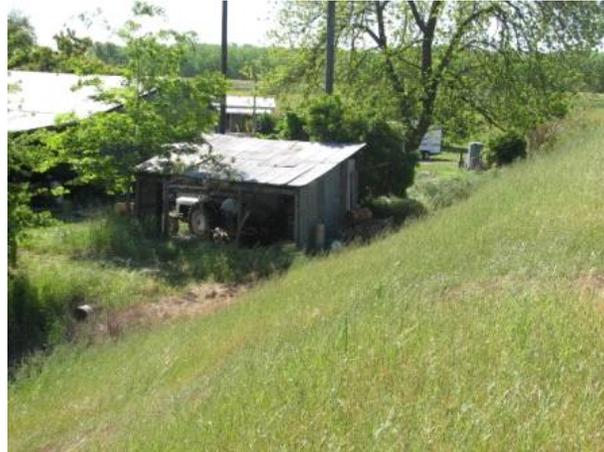
Levee Mile Report Line	26
Start Levee Mile	4.20
End Levee Mile	4.20
Location	Land Side
Category	Earthen Levee
Item	Encroachments
The equipment shed encroaches into the toe of the levee.	
johngw_f_20130924_379.jpg

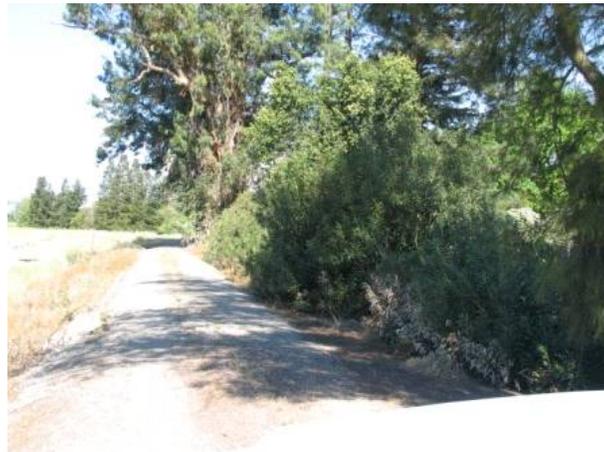
Levee Mile Report Line	28
Start Levee Mile	5.38
End Levee Mile	5.38
Location	Land Side
Category	Earthen Levee
Item	Vegetation
The landscape completely blocks the landside slope and toe.	
johngw_f_20130924_381.jpg

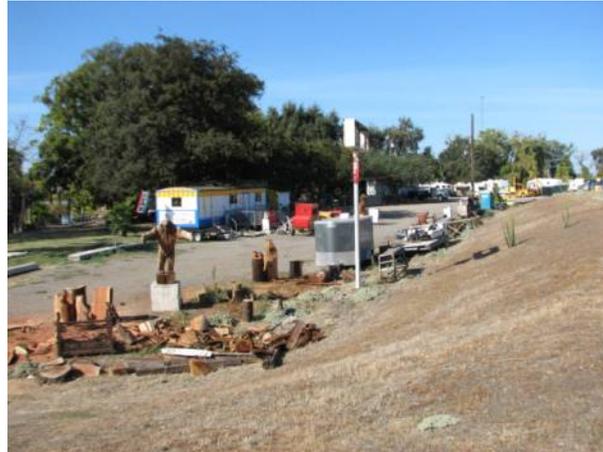
Levee Mile Report Line	29
Start Levee Mile	5.67
End Levee Mile	5.75
Location	Water Side
Category	Earthen Levee
Item	Encroachments
String Razas Fall 2013	
johngw_f_20131007_939.JPG

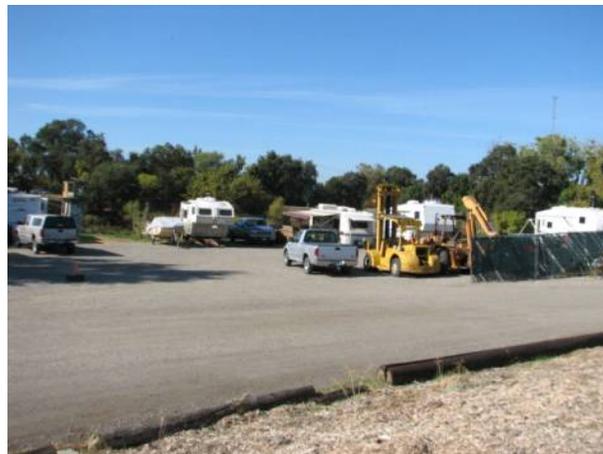
Levee Mile Report Line	29
Start Levee Mile	5.67
End Levee Mile	5.75
Location	Water Side
Category	Earthen Levee
Item	Encroachments
String Razas RV park Fall 2013	
johngw_f_20131007_940.JPG

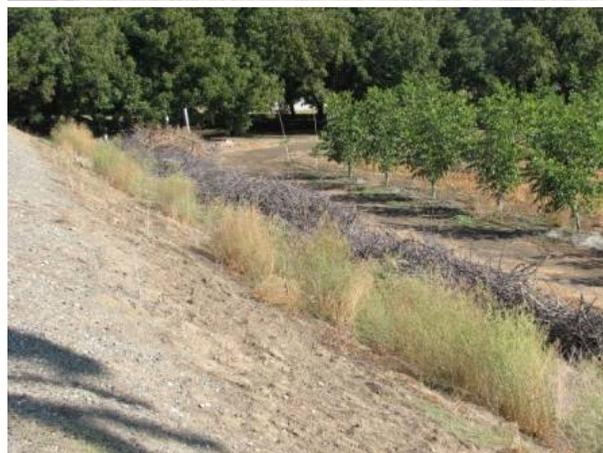
Levee Mile Report Line	30
Start Levee Mile	7.10
End Levee Mile	7.16
Location	Land Side
Category	Earthen Levee
Item	Encroachments
The land owner has piled prunings along the levee toe.	
johngw_f_20130924_491.jpg

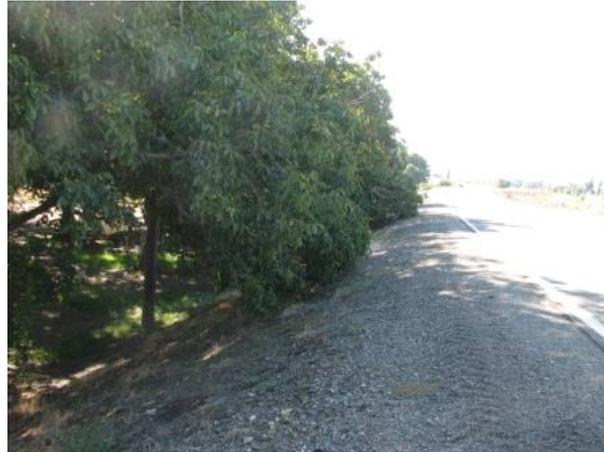
Levee Mile Report Line	31
Start Levee Mile	7.21
End Levee Mile	7.21
Location	Land Side
Category	Earthen Levee
Item	Trim / Thin Trees
Trees need to be trimmed to the height of 5 feet to see the slope.	
johngw_f_20130924_492.jpg

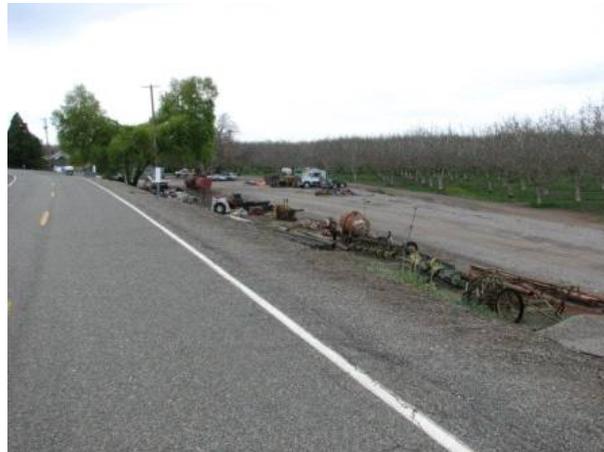
Levee Mile Report Line	32
Start Levee Mile	7.57
End Levee Mile	7.57
Location	Land Side
Category	Earthen Levee
Item	Encroachments
Equipment along landside toe. Photo was taken in spring 2010.	
johngw_f_20130924_383.jpg

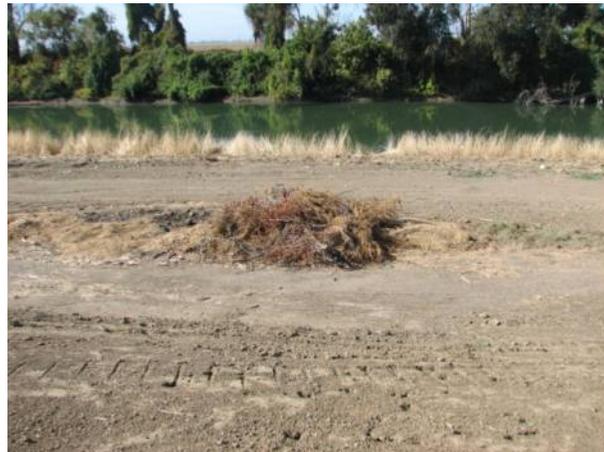
Levee Mile Report Line	33
Start Levee Mile	7.62
End Levee Mile	7.62
Location	Water Side
Category	Earthen Levee
Item	Encroachments
A pile of brush on waterside berm. Fall 2013	
johngw_f_20131007_941.JPG

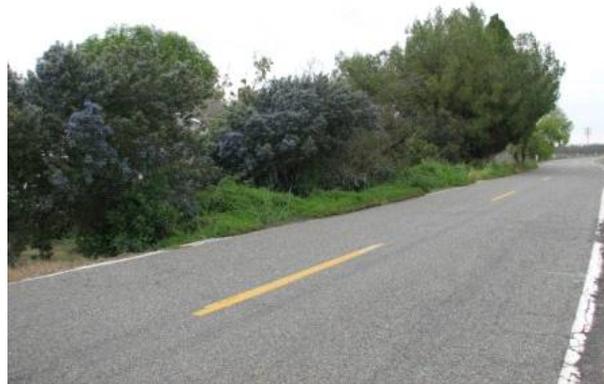
Levee Mile Report Line	34
Start Levee Mile	7.66
End Levee Mile	7.66
Location	Land Side
Category	Earthen Levee
Item	Vegetation
Landscape shrubs, photo taken in spring 2010.	
johngw_f_20130924_384.jpg

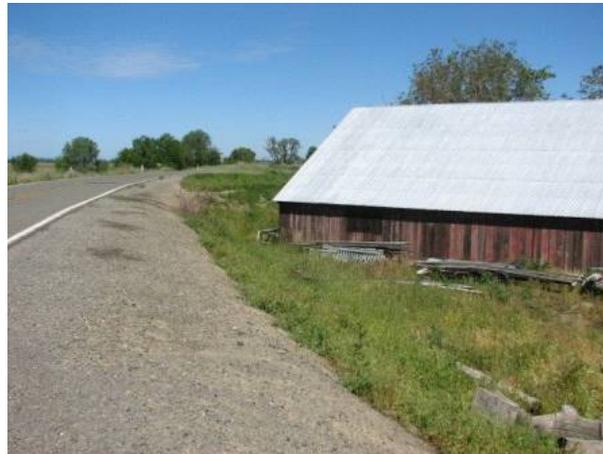
Levee Mile Report Line	37
Start Levee Mile	8.79
End Levee Mile	8.79
Location	Land Side
Category	Earthen Levee
Item	Encroachments
The corner of the building has encroached into the toe.	
johngw_f_20130924_385.jpg

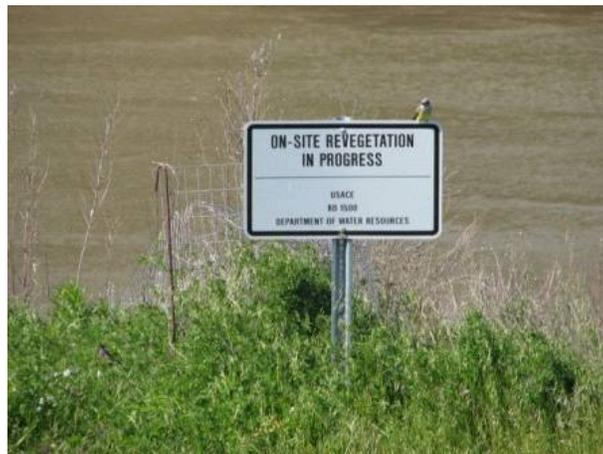
Levee Mile Report Line	38
Start Levee Mile	9.47
End Levee Mile	9.71
Location	Water Side
Category	Earthen Levee
Item	Vegetation
Another revegetation site photo taken spring 2012.	
johngw_f_20130924_464.jpg

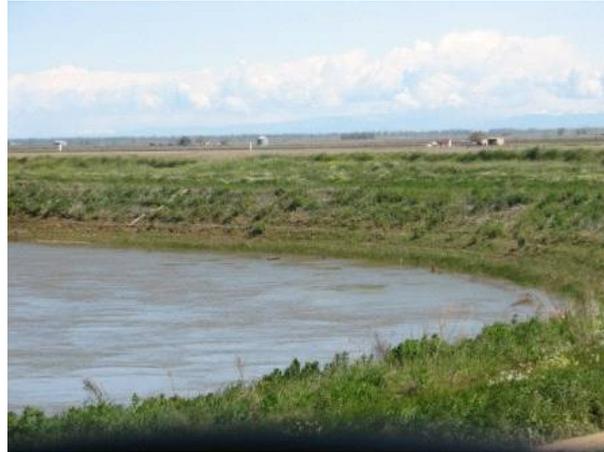
Levee Mile Report Line	38
Start Levee Mile	9.47
End Levee Mile	9.71
Location	Water Side
Category	Earthen Levee
Item	Vegetation
A revegetation site on the waterside bank with sprinklers installed.	
johngw_f_20130924_465.jpg

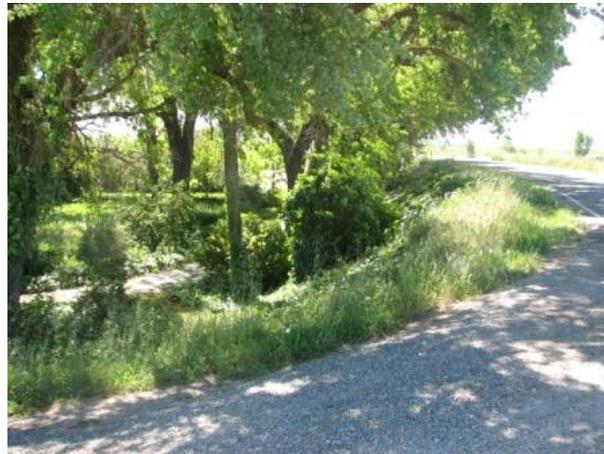
Levee Mile Report Line	41
Start Levee Mile	11.43
End Levee Mile	11.43
Location	Land Side
Category	Earthen Levee
Item	Vegetation
The homeowner has landscaped the levee slope.	
johngw_f_20130924_389.jpg

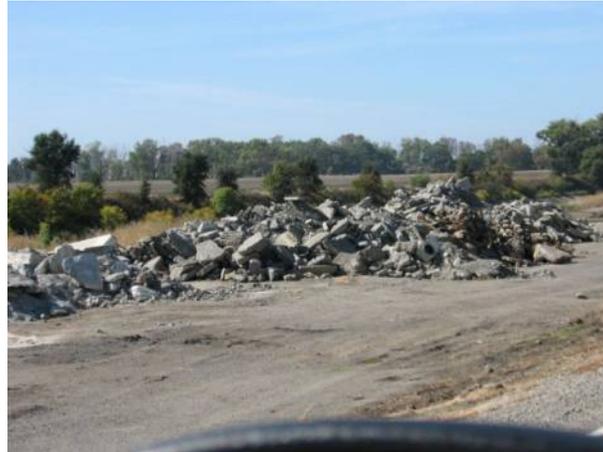
Levee Mile Report Line	43
Start Levee Mile	11.93
End Levee Mile	11.93
Location	Water Side
Category	Earthen Levee
Item	Encroachments
Concret debris stockpiled on the waterside. Fall 2013	
johngw_f_20131007_942.JPG

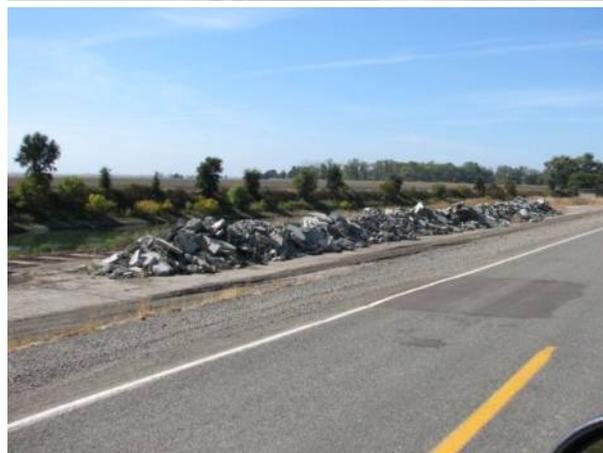
Levee Mile Report Line	45
Start Levee Mile	12.02
End Levee Mile	12.02
Location	Water Side
Category	Earthen Levee
Item	Encroachments
Another pile of concrete debris on the waterside. Fall 2013	
johngw_f_20131007_943.JPG

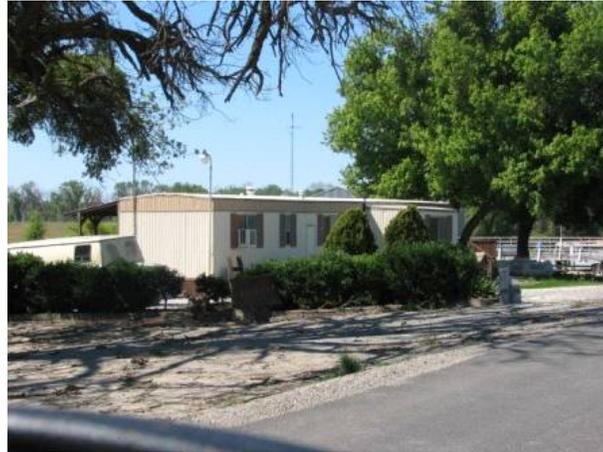
Levee Mile Report Line	46
Start Levee Mile	12.15
End Levee Mile	12.15
Location	Water Side
Category	Earthen Levee
Item	Encroachments
<p>The mobile home is the home of the operator for Sutter Municiple Water.</p>	
<p>johngw_f_20130924_392.jpg</p>

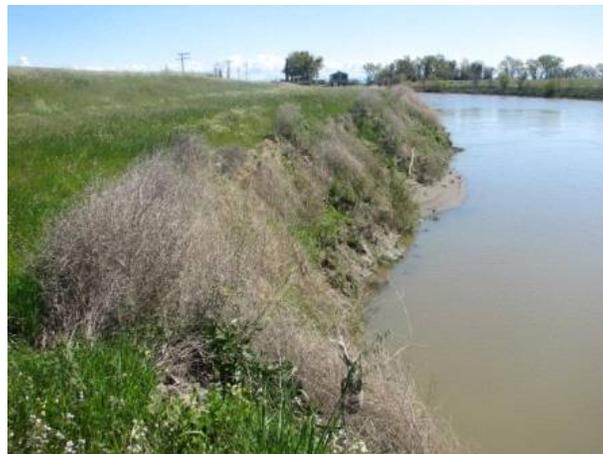
Levee Mile Report Line	47
Start Levee Mile	12.31
End Levee Mile	12.31
Location	Water Side
Category	Earthen Levee
Item	Erosion / Bank Caving
<p>An erosion site along the embankment, photo taken spring 2012.</p>	
<p>johngw_f_20130924_439.jpg</p>

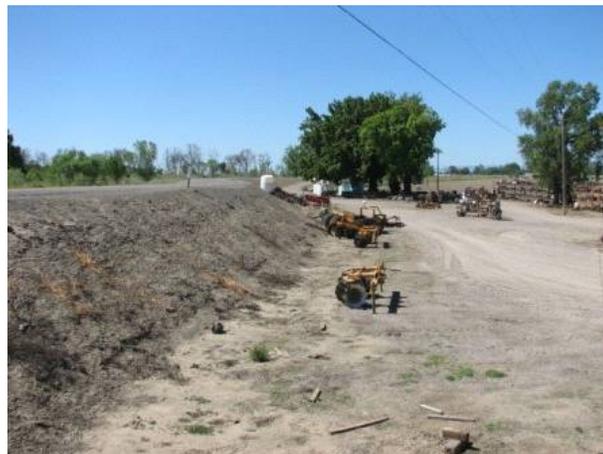
Levee Mile Report Line	48
Start Levee Mile	12.55
End Levee Mile	12.55
Location	Land Side
Category	Earthen Levee
Item	Encroachments
<p>There is equipment parked along the toe of the levee.</p>	
<p>johngw_f_20130924_393.jpg</p>

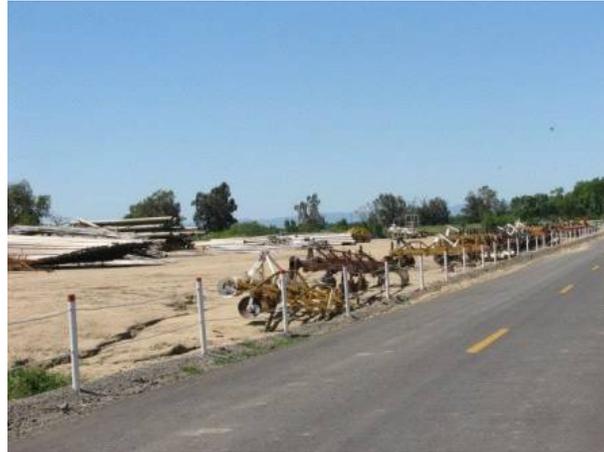
Levee Mile Report Line	49
Start Levee Mile	12.93
End Levee Mile	12.93
Location	Crown
Category	Earthen Levee
Item	Encroachments
<p>On top of the crown is farm equipment and irrigation pipe.</p>	
<p>johngw_f_20130924_394.jpg</p>

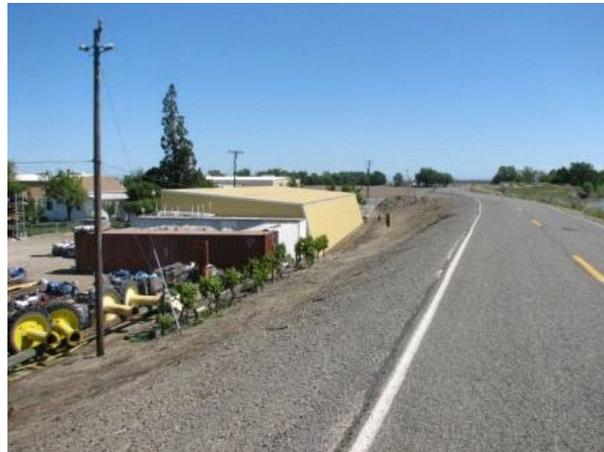
Levee Mile Report Line	50
Start Levee Mile	13.15
End Levee Mile	13.15
Location	Land Side
Category	Earthen Levee
Item	Encroachments
<p>The buildings backside was built into the toe of the levee.</p>	
<p>johngw_f_20130924_395.jpg</p>

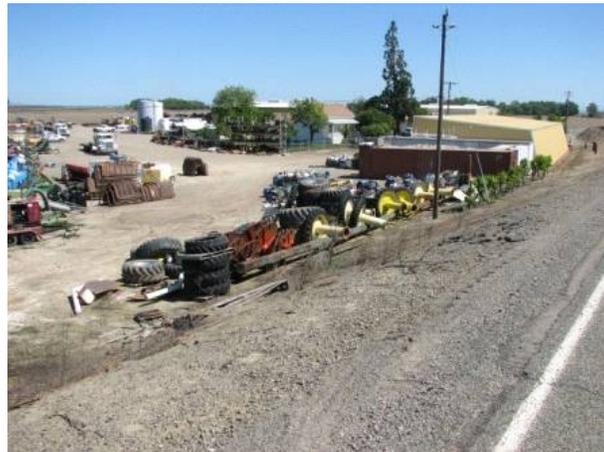
Levee Mile Report Line	51
Start Levee Mile	13.18
End Levee Mile	13.18
Location	Land Side
Category	Earthen Levee
Item	Encroachments
<p>Next to the building there are tires and axles stored at the toe.</p>	
<p>johngw_f_20130924_501.jpg</p>

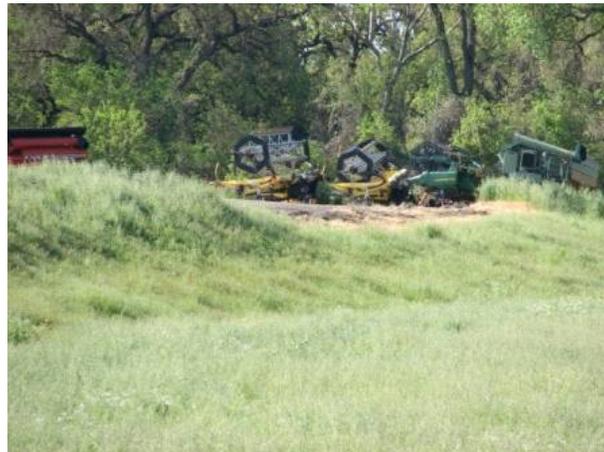
Levee Mile Report Line	54
Start Levee Mile	14.13
End Levee Mile	14.13
Location	Water Side
Category	Earthen Levee
Item	Encroachments
View of equipment. Photo was taken in spring 2010.	
johngw_f_20130924_397.jpg

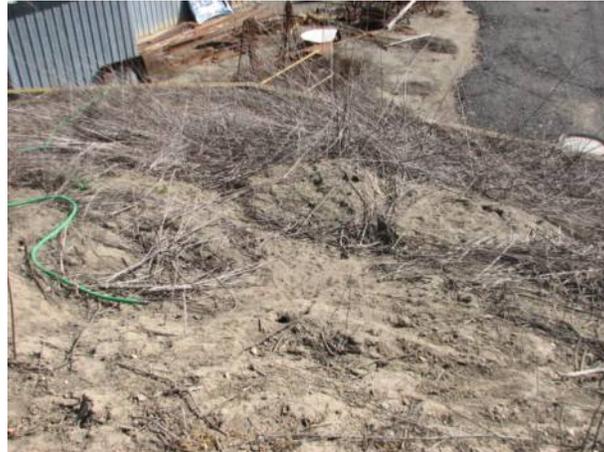
Levee Mile Report Line	55
Start Levee Mile	14.32
End Levee Mile	14.32
Location	Land Side
Category	Earthen Levee
Item	Animal Control
Rodent hole in the levee slope above the retaining wall, Spring 2013	
johngw_f_20130924_478.JPG

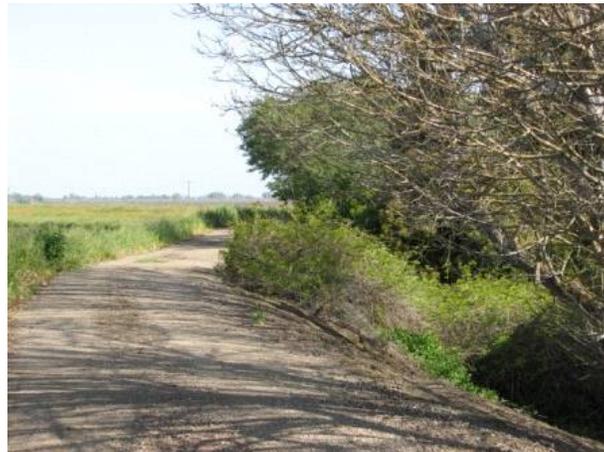
Levee Mile Report Line	57
Start Levee Mile	14.39
End Levee Mile	14.39
Location	Land Side
Category	Earthen Levee
Item	Vegetation
Landscape shrubs on shoulder. Photo was taken in spring 2010.	
johngw_f_20130924_403.jpg

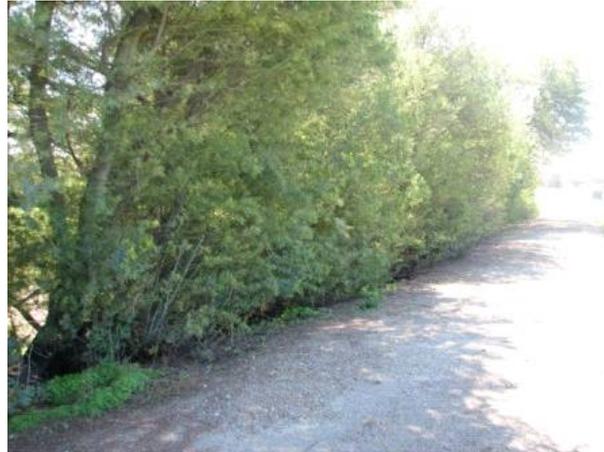
The trees on the landside slope blocks the view of the slope, photo taken spring 2012.

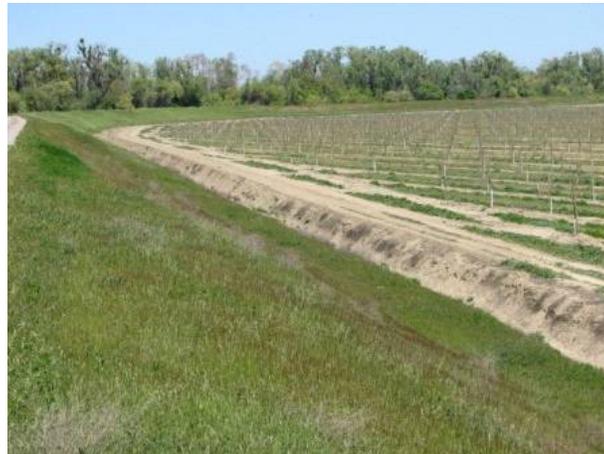
Levee Mile Report Line	59
Start Levee Mile	14.86
End Levee Mile	15.93
Location	Land Side
Category	Earthen Levee
Item	Encroachments

Agricultural ditch, photo taken in spring 2010.

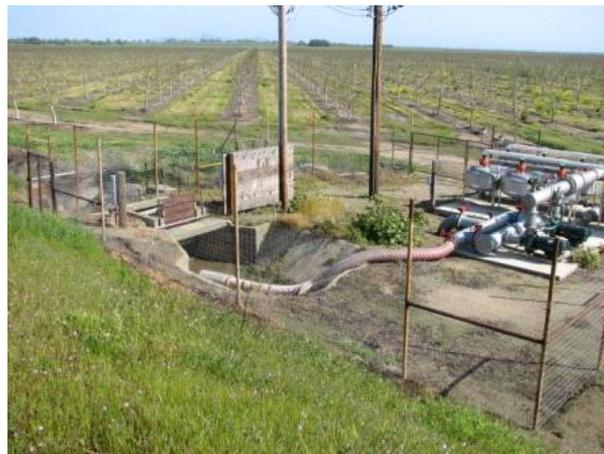
Fence into levee toe, photo taken in spring 2010.

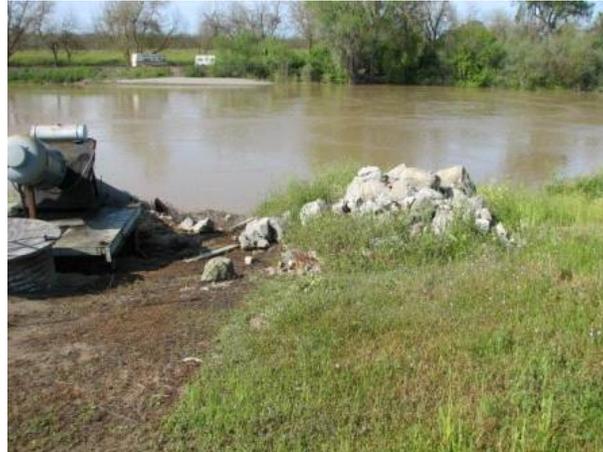
Levee Mile Report Line	61
Start Levee Mile	15.27
End Levee Mile	15.27
Location	Water Side
Category	Earthen Levee
Item	Encroachments
Rip rap and concrete debris, photo taken in spring 2010.	
johngw_f_20130924_390.jpg

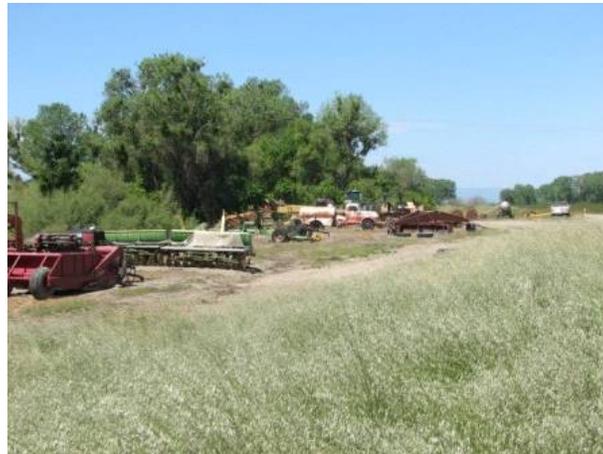
Levee Mile Report Line	62
Start Levee Mile	15.94
End Levee Mile	15.94
Location	Water Side
Category	Earthen Levee
Item	Encroachments
Farm equipment has been parked on the waterside berm.	
johngw_f_20130924_404.jpg

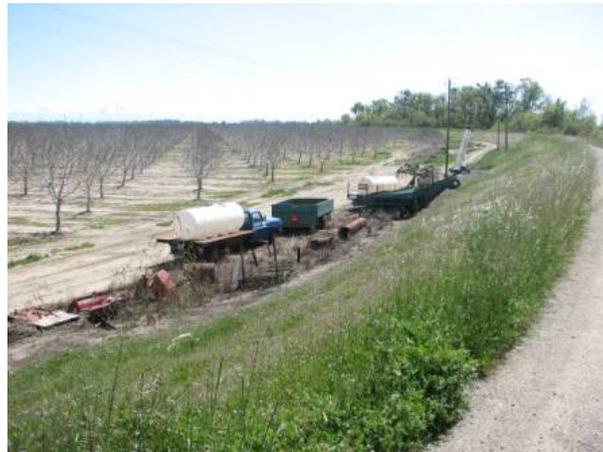
Levee Mile Report Line	63
Start Levee Mile	16.37
End Levee Mile	16.37
Location	Land Side
Category	Earthen Levee
Item	Encroachments
The equipment is parked along the toe of the levee, photo taken spring 2012.	
johngw_f_20130924_469.jpg

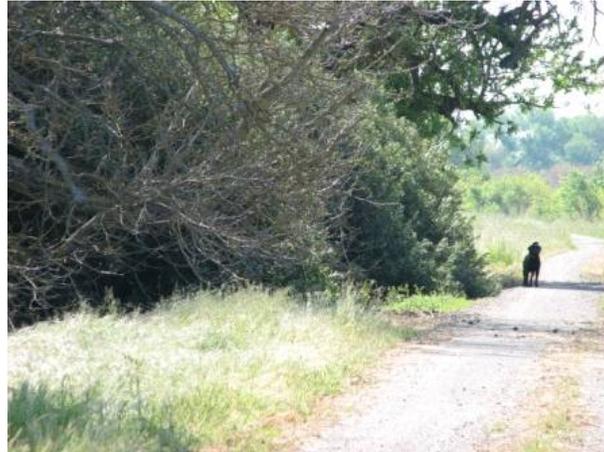
Levee Mile Report Line	64
Start Levee Mile	16.48
End Levee Mile	16.48
Location	Land Side
Category	Earthen Levee
Item	Vegetation
Landscape shrubs, photo taken in spring 2010.	
johngw_f_20130924_405.jpg

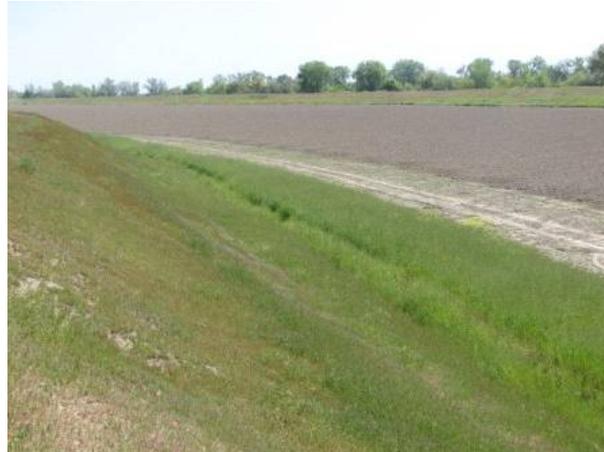
Levee Mile Report Line	65
Start Levee Mile	16.86
End Levee Mile	17.45
Location	Land Side
Category	Earthen Levee
Item	Encroachments
Agricultural ditch, photo taken in spring 2010.	
johngw_f_20130924_496.jpg

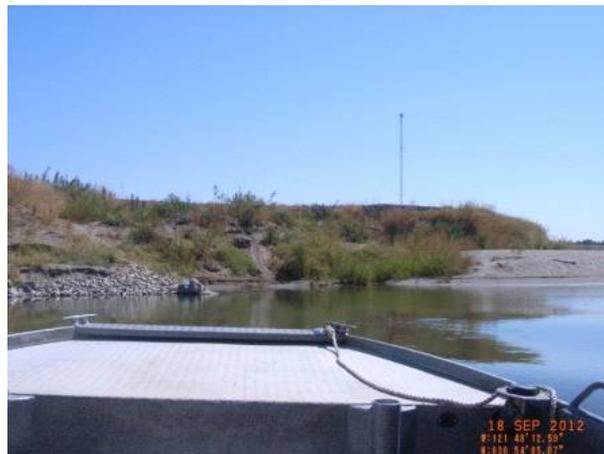
Levee Mile Report Line	66
Start Levee Mile	18.28
End Levee Mile	18.28
Location	Water Side
Category	Supplemental
Item	USACE Erosion Survey
USACE 2012 Photo #1	
USACE2013_SAC_103-4_L_1.jpg

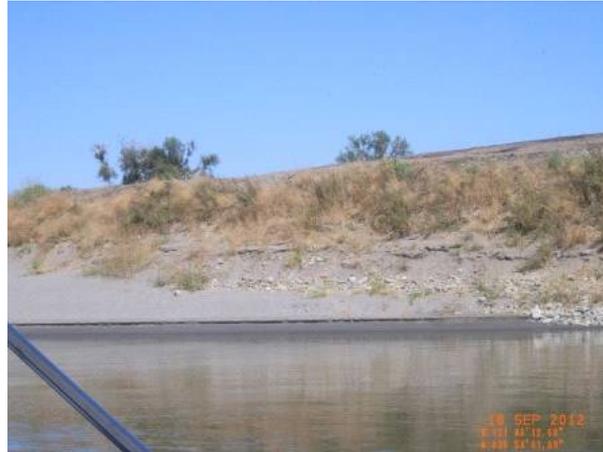
Levee Mile Report Line	66
Start Levee Mile	18.28
End Levee Mile	18.28
Location	Water Side
Category	Supplemental
Item	USACE Erosion Survey
USACE 2012 Photo #2	
USACE2013_SAC_103-4_L_2.jpg

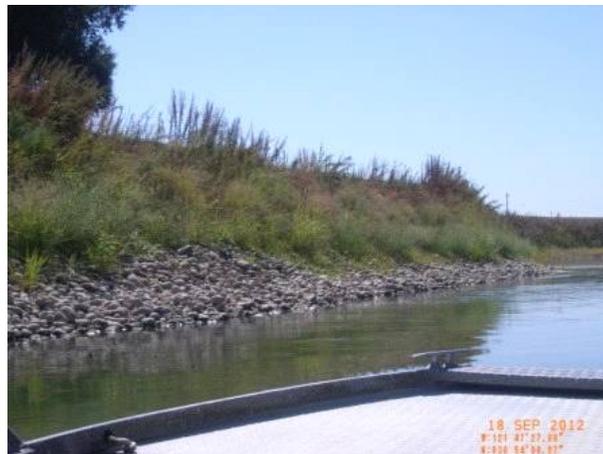
Levee Mile Report Line	67
Start Levee Mile	18.38
End Levee Mile	18.38
Location	Water Side
Category	Supplemental
Item	USACE Erosion Survey
USACE 2012 Photo #1	
USACE2013_SAC_104-0_L_1.jpg

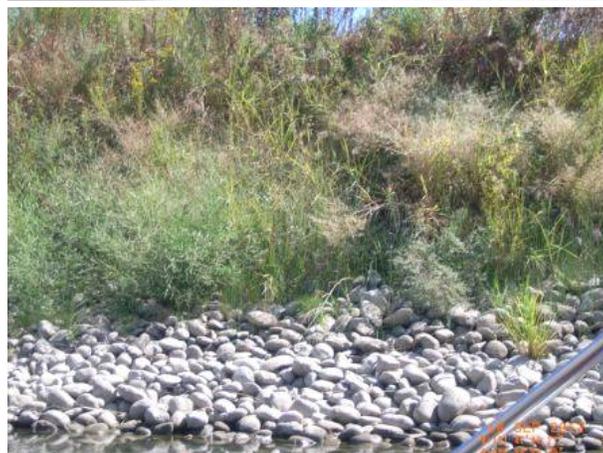
Levee Mile Report Line	67
Start Levee Mile	18.38
End Levee Mile	18.38
Location	Water Side
Category	Supplemental
Item	USACE Erosion Survey
USACE 2012 Photo #2	
USACE2013_SAC_104-0_L_2.jpg

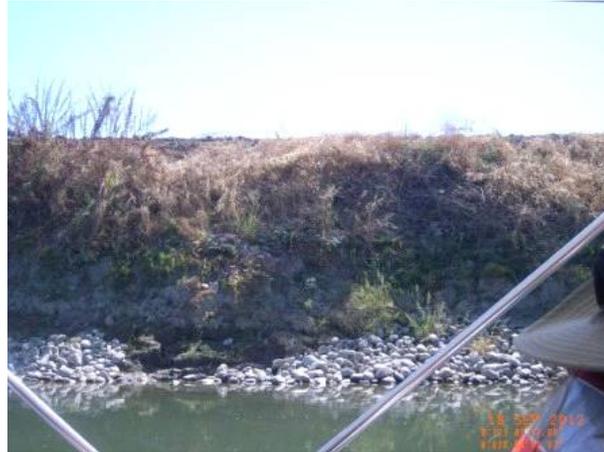
Levee Mile Report Line	67
Start Levee Mile	18.38
End Levee Mile	18.38
Location	Water Side
Category	Supplemental
Item	USACE Erosion Survey
USACE 2012 Photo #3	
USACE2013_SAC_104-0_L_3.jpg

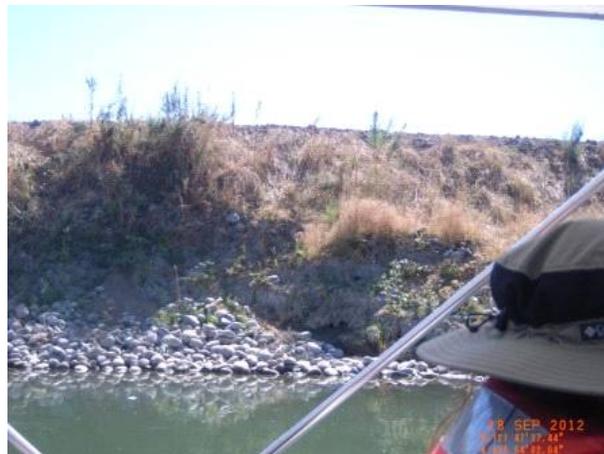
Levee Mile Report Line	67
Start Levee Mile	18.38
End Levee Mile	18.38
Location	Water Side
Category	Supplemental
Item	USACE Erosion Survey
USACE 2012 Photo #4	
USACE2013_SAC_104-0_L_4.jpg

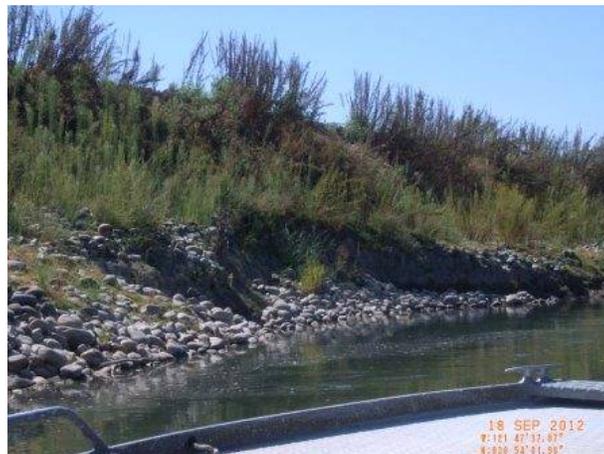
Levee Mile Report Line	67
Start Levee Mile	18.38
End Levee Mile	18.38
Location	Water Side
Category	Supplemental
Item	USACE Erosion Survey
USACE 2012 Photo #5	
USACE2013_SAC_104-0_L_5.jpg

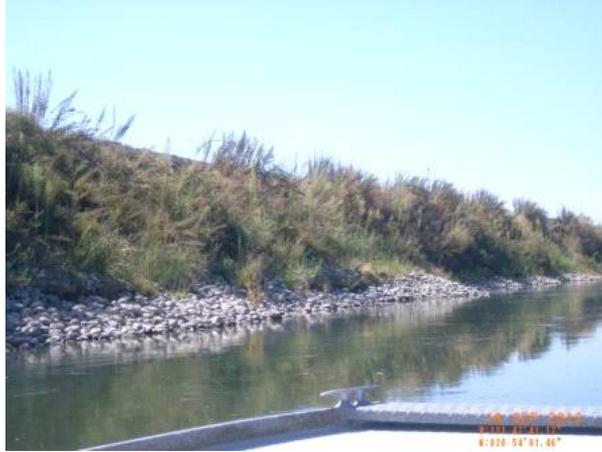
Levee Mile Report Line	67
Start Levee Mile	18.38
End Levee Mile	18.38
Location	Water Side
Category	Supplemental
Item	USACE Erosion Survey
USACE 2012 Photo #6	
USACE2013_SAC_104-0_L_6.jpg

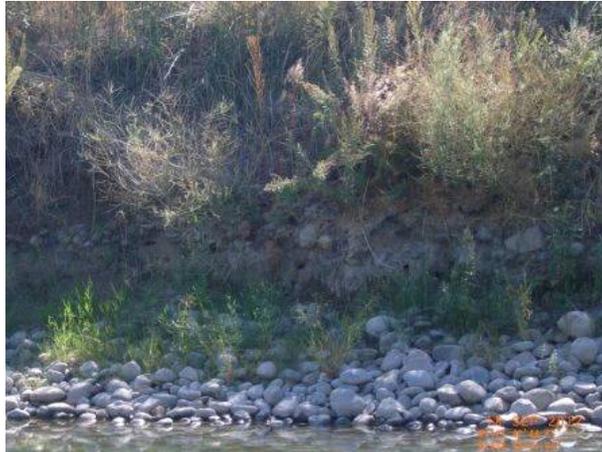
Levee Mile Report Line	67
Start Levee Mile	18.38
End Levee Mile	18.38
Location	Water Side
Category	Supplemental
Item	USACE Erosion Survey
USACE 2012 Photo #7	
USACE2013_SAC_104-0_L_7.jpg

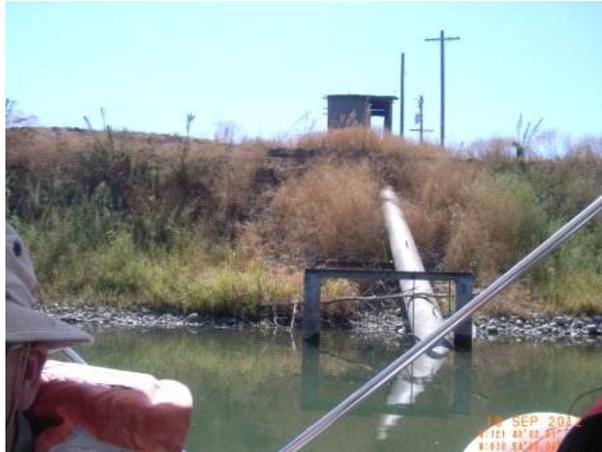
Levee Mile Report Line	67
Start Levee Mile	18.38
End Levee Mile	18.38
Location	Water Side
Category	Supplemental
Item	USACE Erosion Survey
USACE 2012 Photo #8	
USACE2013_SAC_104-0_L_8.jpg

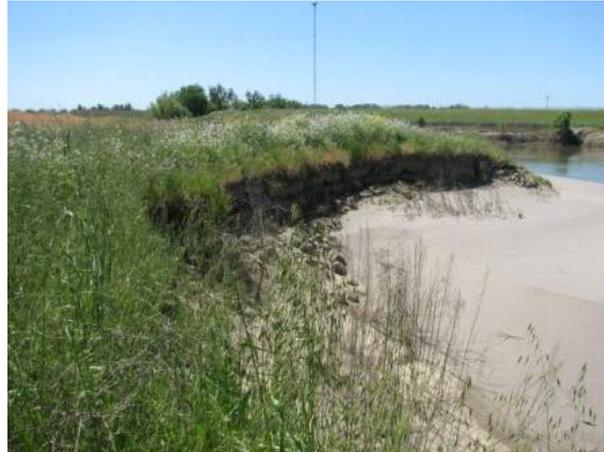
Levee Mile Report Line	68
Start Levee Mile	18.50
End Levee Mile	18.50
Location	Water Side
Category	Earthen Levee
Item	Erosion / Bank Caving
This is an inside curve in the river and erosion has occurred.	
johngw_f_20130924_440.jpg

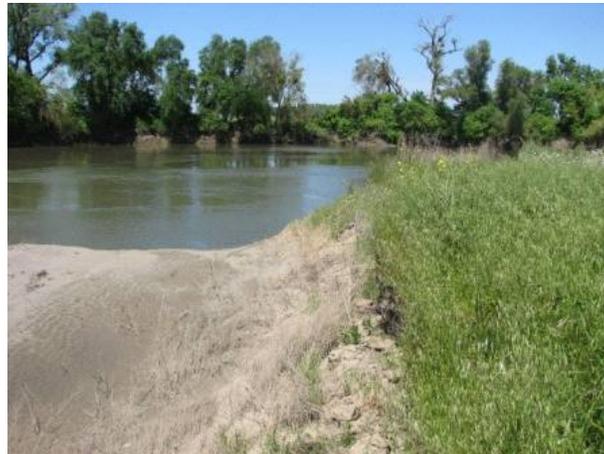
Levee Mile Report Line	68
Start Levee Mile	18.50
End Levee Mile	18.50
Location	Water Side
Category	Earthen Levee
Item	Erosion / Bank Caving
This is an upstream view of the same erosion.	
johngw_f_20130924_441.jpg

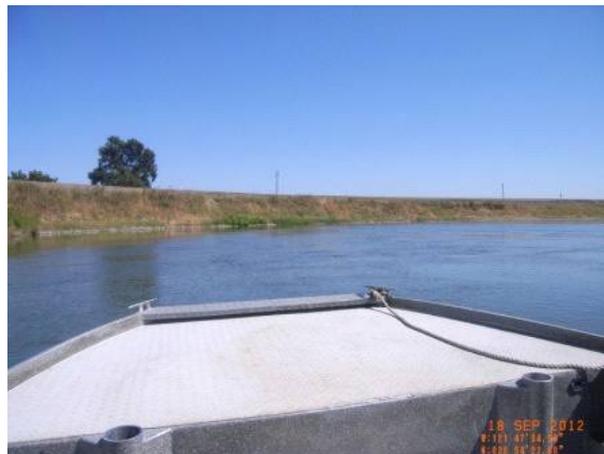
Levee Mile Report Line	69
Start Levee Mile	19.16
End Levee Mile	19.16
Location	Water Side
Category	Supplemental
Item	USACE Erosion Survey
USACE 2012 Photo #1	
USACE2013_SAC_104-5_L_1.jpg

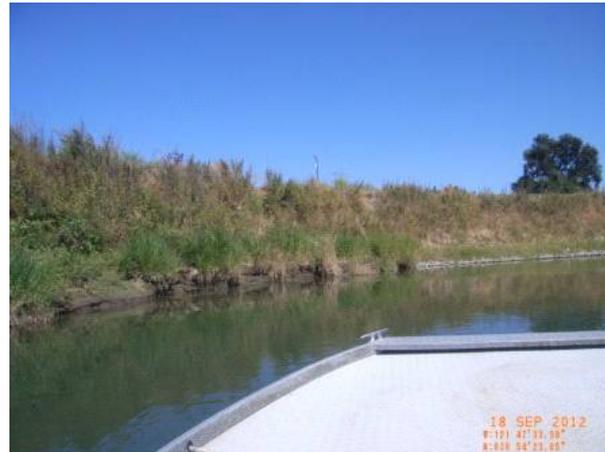
Levee Mile Report Line	69
Start Levee Mile	19.16
End Levee Mile	19.16
Location	Water Side
Category	Supplemental
Item	USACE Erosion Survey
USACE 2012 Photo #2	
USACE2013_SAC_104-5_L_2.jpg

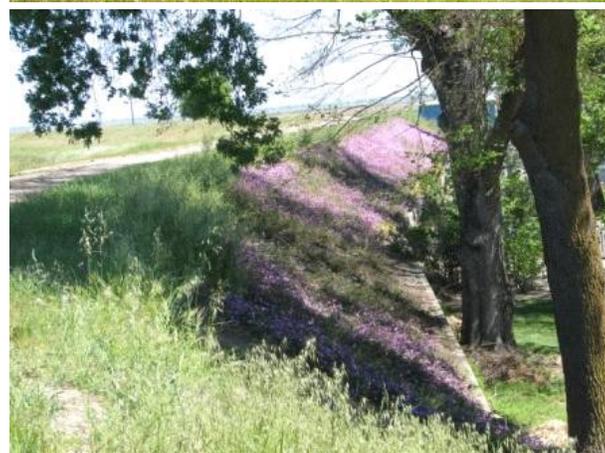
Levee Mile Report Line	71
Start Levee Mile	19.22
End Levee Mile	19.22
Location	Land Side
Category	Earthen Levee
Item	Vegetation
The groundcover is on the levee slope above the concrete retaining wall. The groundcover is irrigated.	
johngw_f_20130924_413.jpg

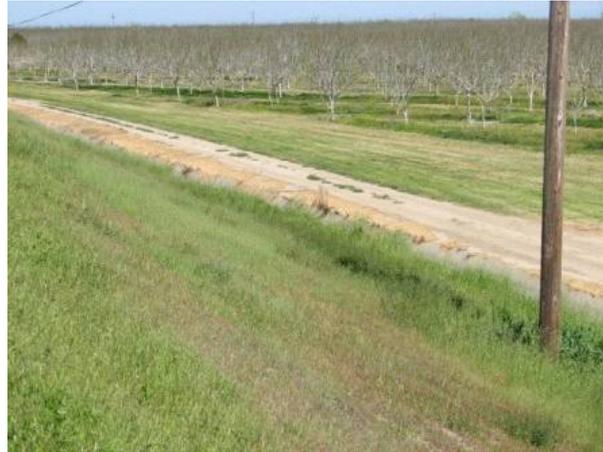
Levee Mile Report Line	74
Start Levee Mile	20.86
End Levee Mile	21.40
Location	Land Side
Category	Earthen Levee
Item	Encroachments
Agricultural ditch, photo taken in spring 2010.	
johngw_f_20130924_497.jpg

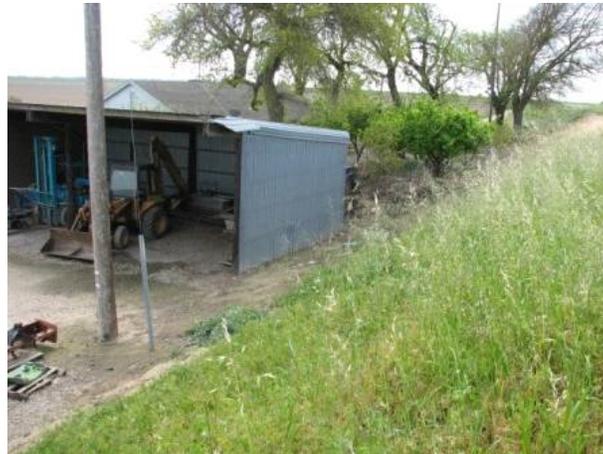
Levee Mile Report Line	80
Start Levee Mile	24.04
End Levee Mile	24.04
Location	Land Side
Category	Earthen Levee
Item	Encroachments
Pole barn and some equipment, photo taken in spring 2010.	
johngw_f_20130924_421.jpg

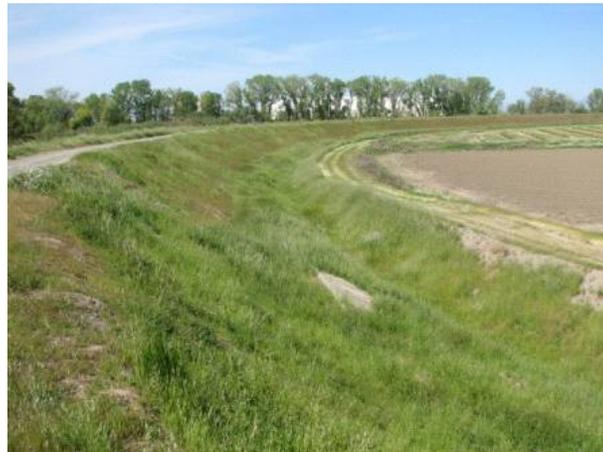
Levee Mile Report Line	81
Start Levee Mile	24.44
End Levee Mile	24.60
Location	Land Side
Category	Earthen Levee
Item	Encroachments
Agricultural ditch, photo taken in spring 2010.	
johngw_f_20130924_498.jpg

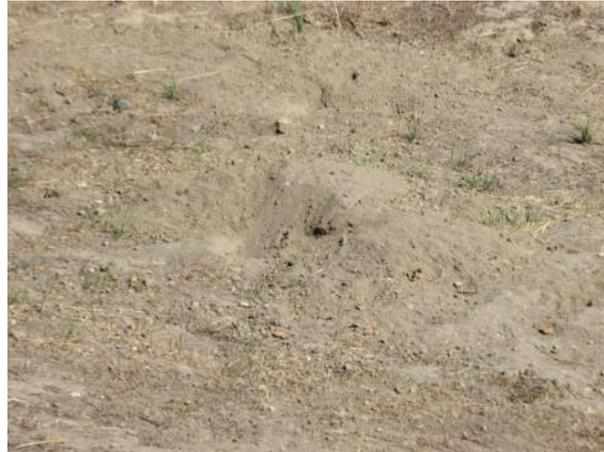
Levee Mile Report Line	83
Start Levee Mile	25.17
End Levee Mile	25.17
Location	Land Side
Category	Earthen Levee
Item	Animal Control
A rodent burrow on the landside Fall 2013	
johngw_f_20131007_944.JPG

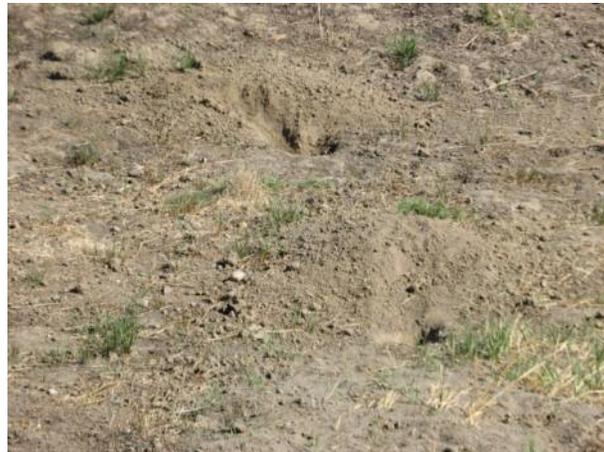
Levee Mile Report Line	83
Start Levee Mile	25.17
End Levee Mile	25.17
Location	Land Side
Category	Earthen Levee
Item	Animal Control
Multiple rodent burrows on landside slope. Fall 2013	
johngw_f_20131007_945.JPG

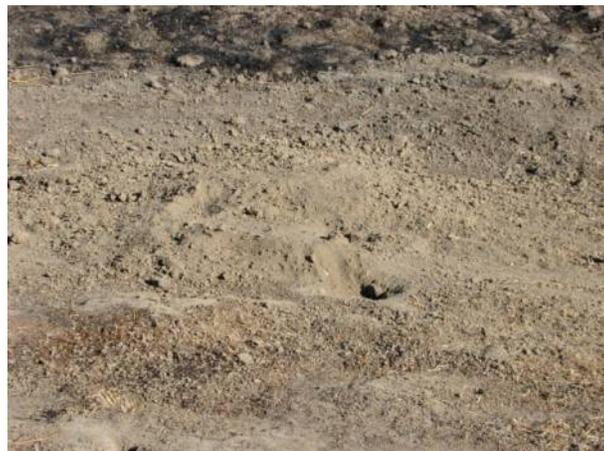
Levee Mile Report Line	84
Start Levee Mile	26.68
End Levee Mile	26.68
Location	Land Side
Category	Earthen Levee
Item	Animal Control
Many rodent holes on the levee slope. Photo fall 2012.	
johngw_f_20130924_486.jpg
